TECHNICAL INSPECTION REPORT

OPERATION CROSSROADS. U.S.S. SKIPJACK (SS184).
TEST BAKER, VOLUME 2[U].

Bureau of Ships Group technical inspection rept.,

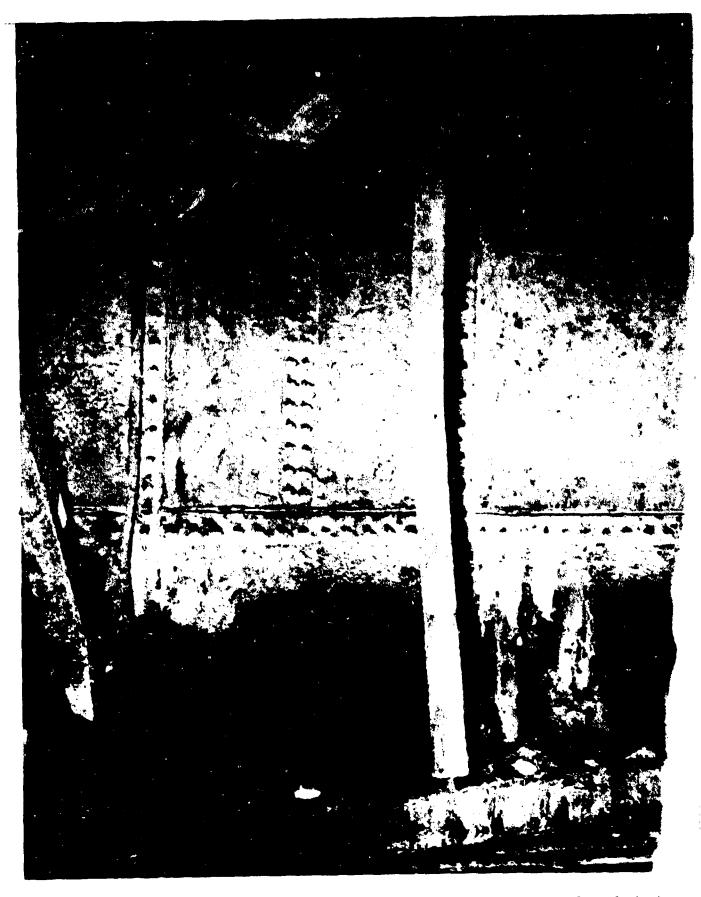
AB-CR-SM-6500-9. Compression failure of superstructure bracket at frame 34, port looking outboard.

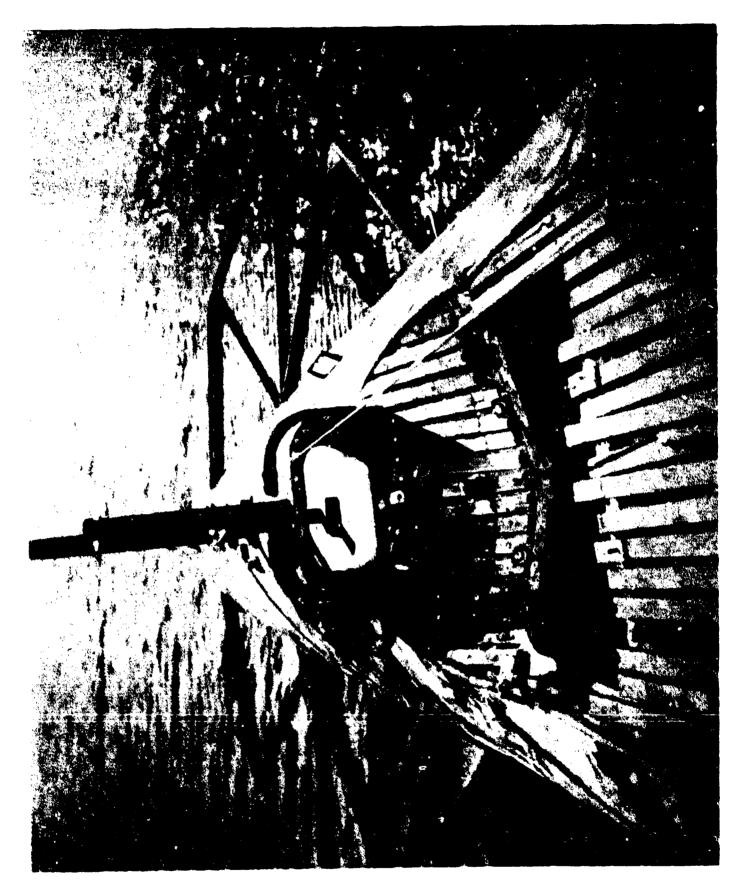
AB-CR-SM-6501-2. Crushed main deck, frames 173-179, looking aft.

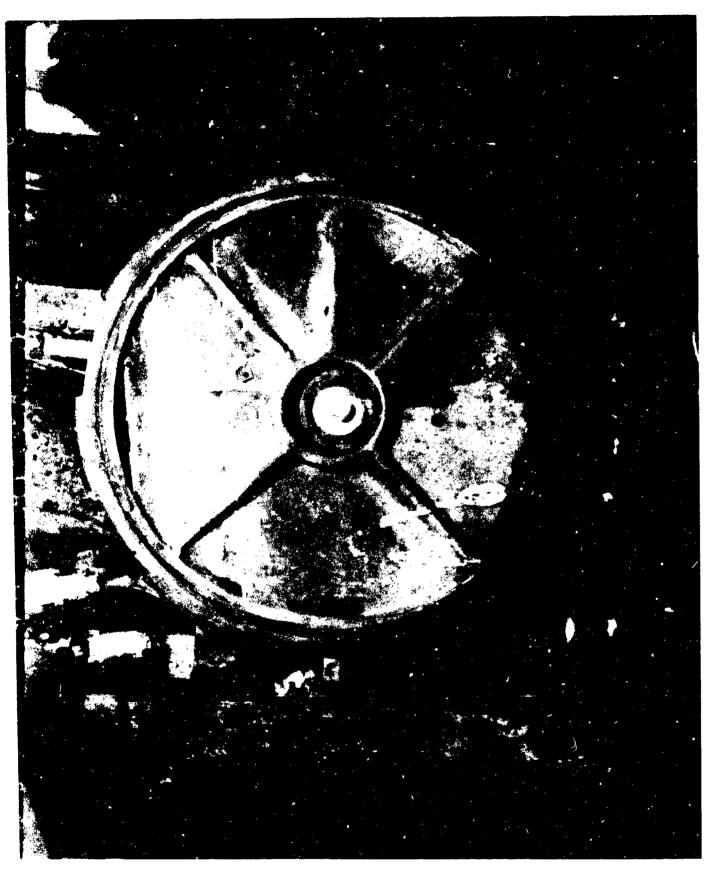
AB-CR-MIG-6518-12. Torpedo tube No. 3 breech door.

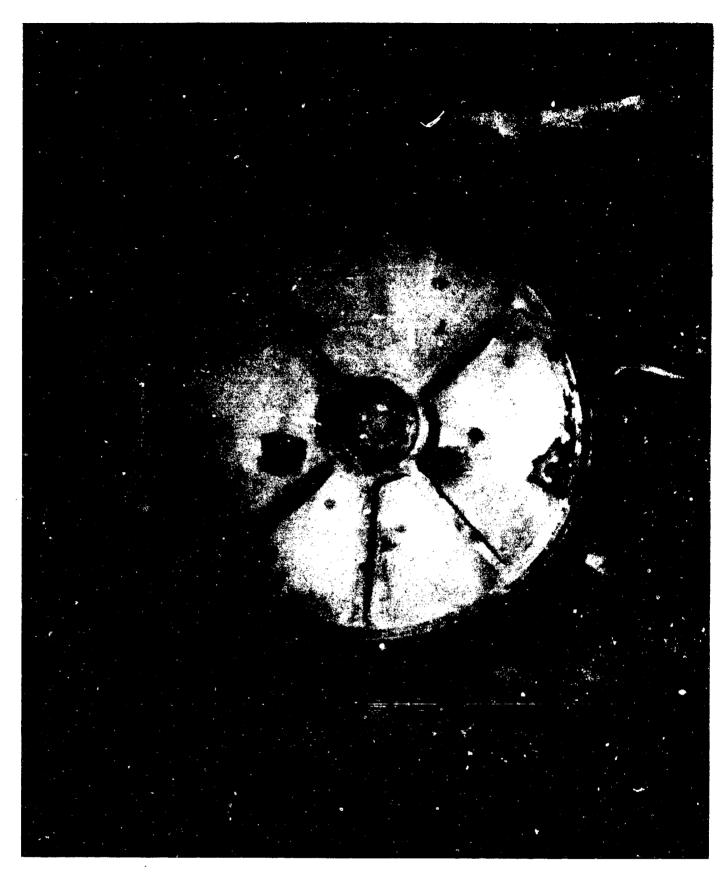
AB-CR-MIG-6519-2. Torpedo tube No. 4 Breech door.

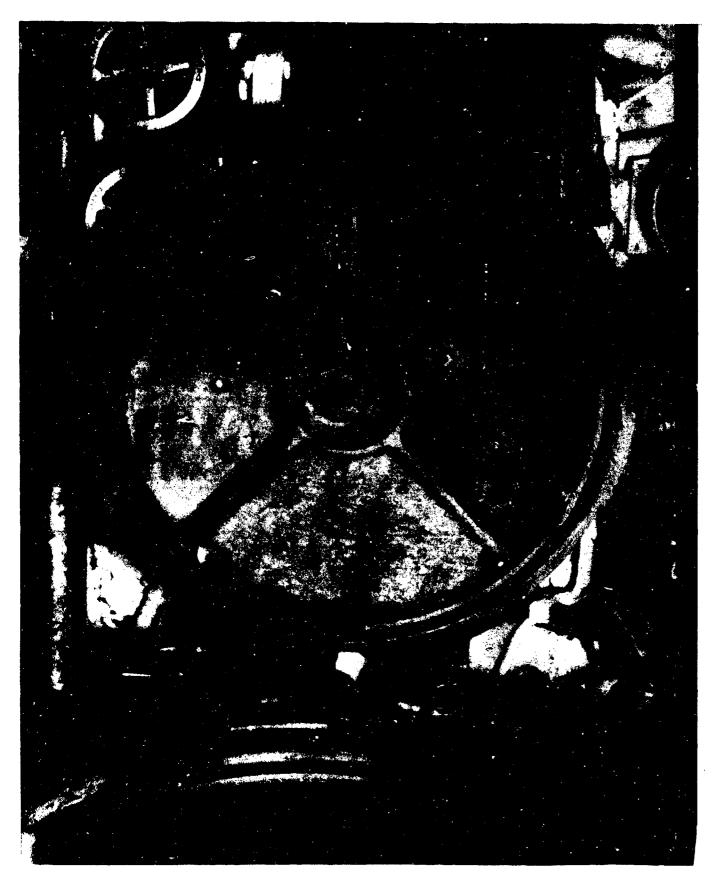
AB-CR-MIG-6516-2. Torpedo tube No. 5 breech door.

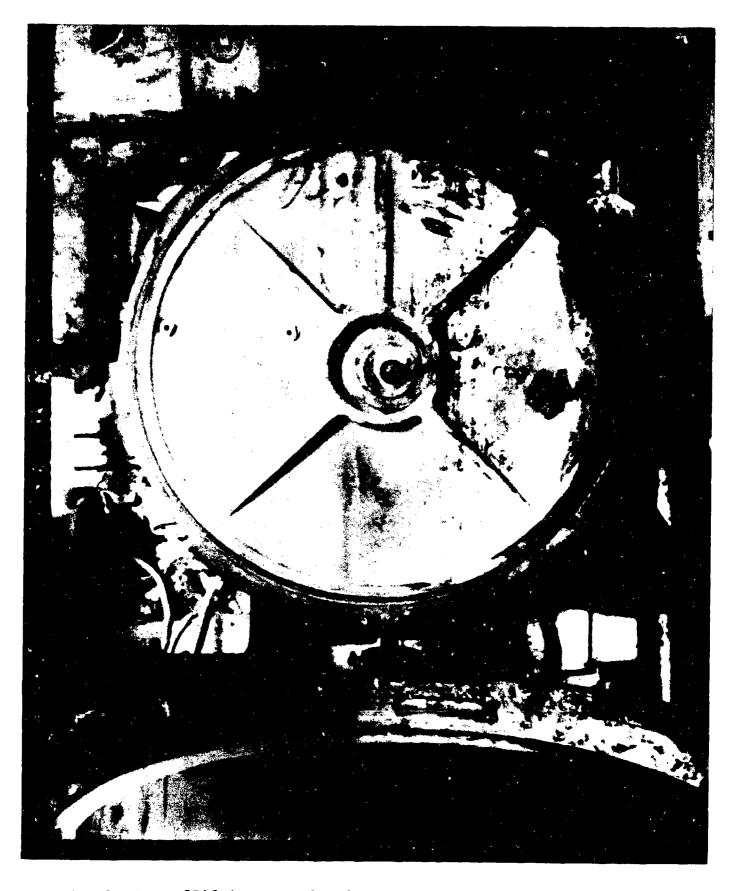
AB-CR-MIG-6516-1. Torpedo tube No. 6 breech door.

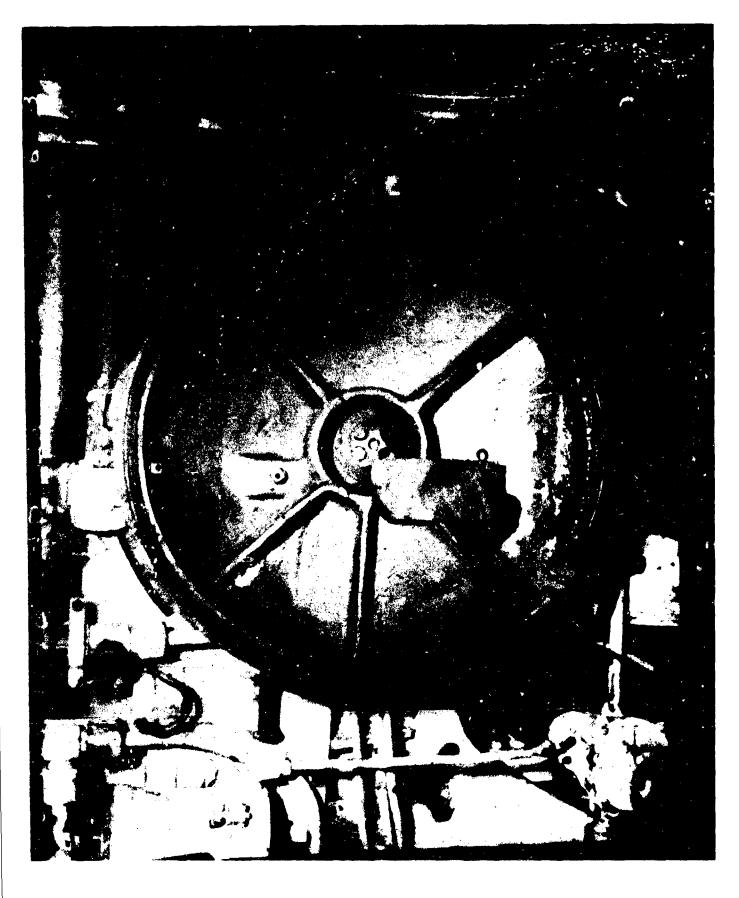
AB-CR-MIG-6516-3. Torpedo tube No. 7 breech door.

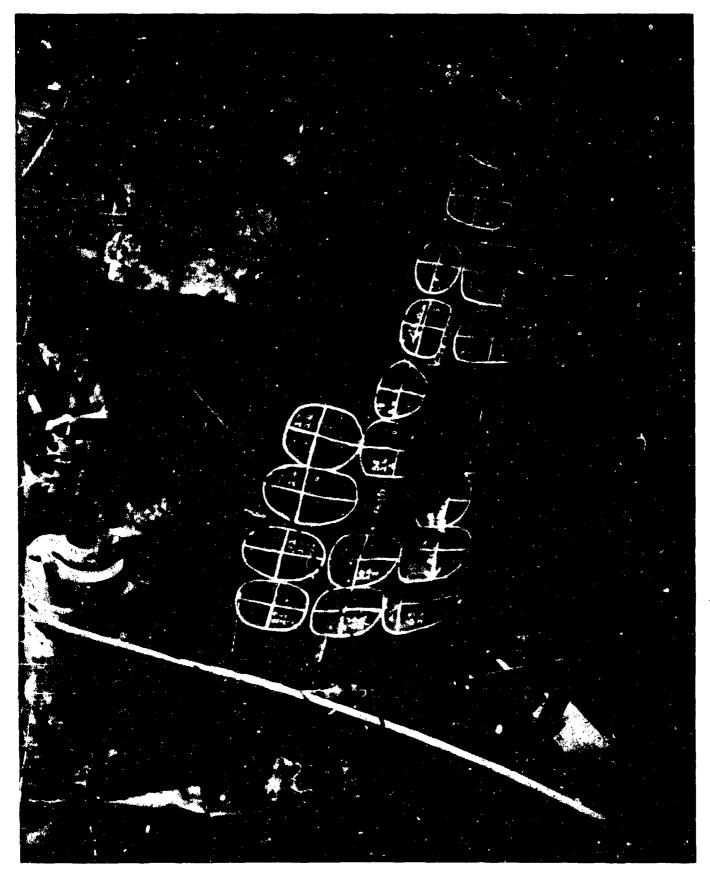
AB-CR-MIK-6529-5. General view of dimples in single hull plating - port side of after engine room, from above.

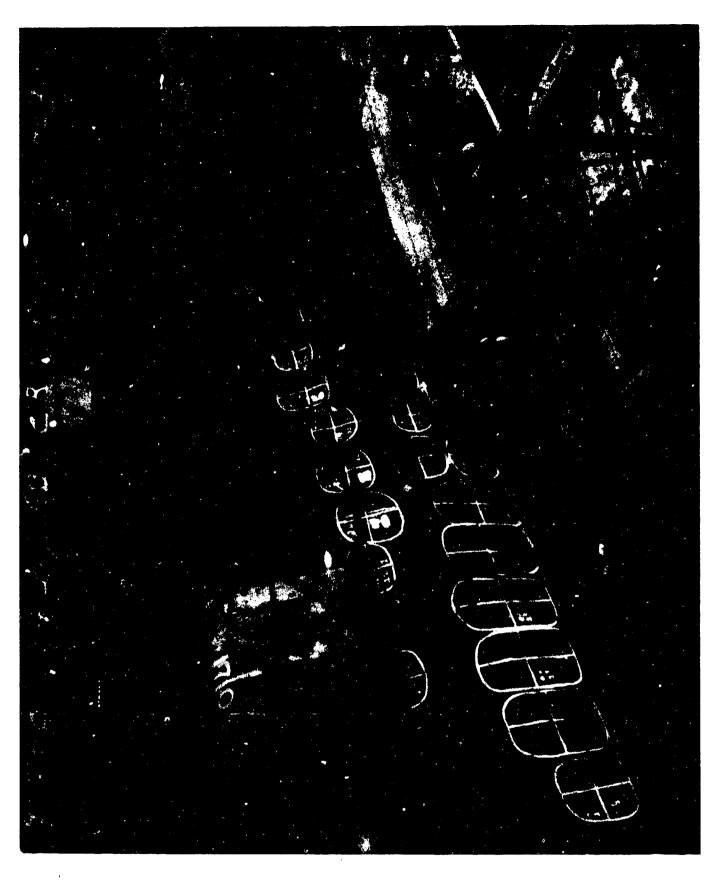
AB-CR-MIK-6529-6. General view of dimples in single hull - port side of after torpedo room - from above.

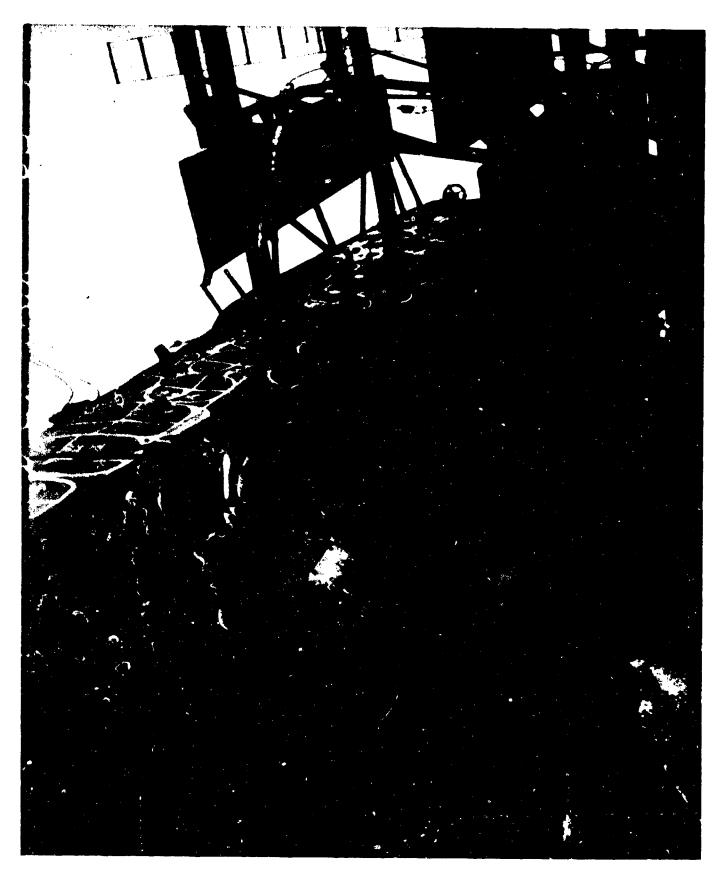
AB-CR-MIK-6529-12. General view of dimples in single hull - port side of after torpedo room, from below.

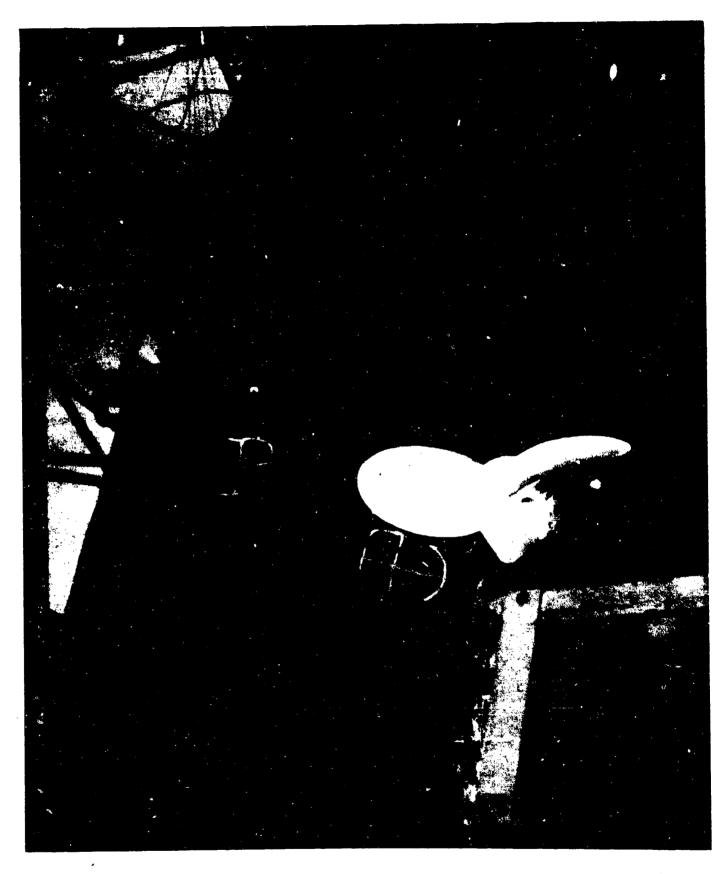
AB-CR-MIK-6530-2. General view of dimples in single hull - starboard side of after torpedo room, from below.

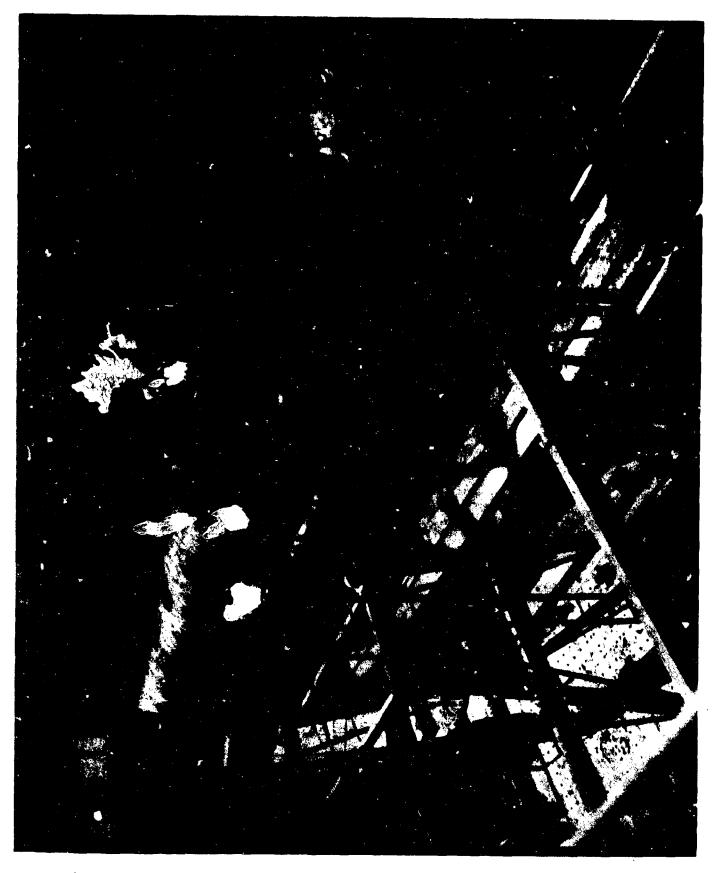
AB-CR-MIK-6529-7. General view of dimples in single hull - starboard side of after torpedo room, from above.

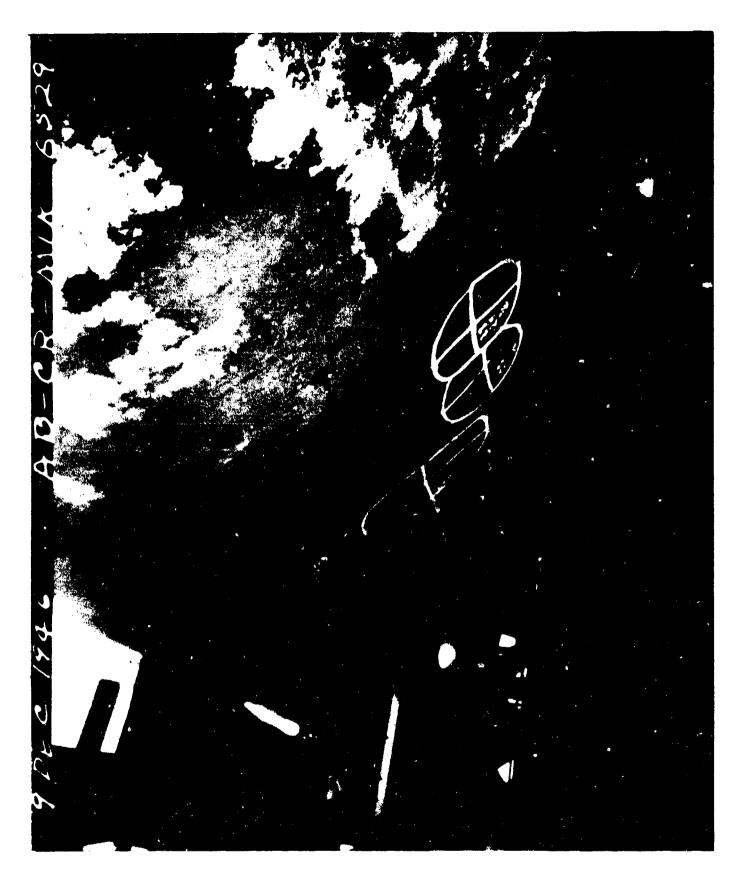
AB-CR-MIK-6529-10. General view of dimples in single hull - starboard side of forward torpedo room.

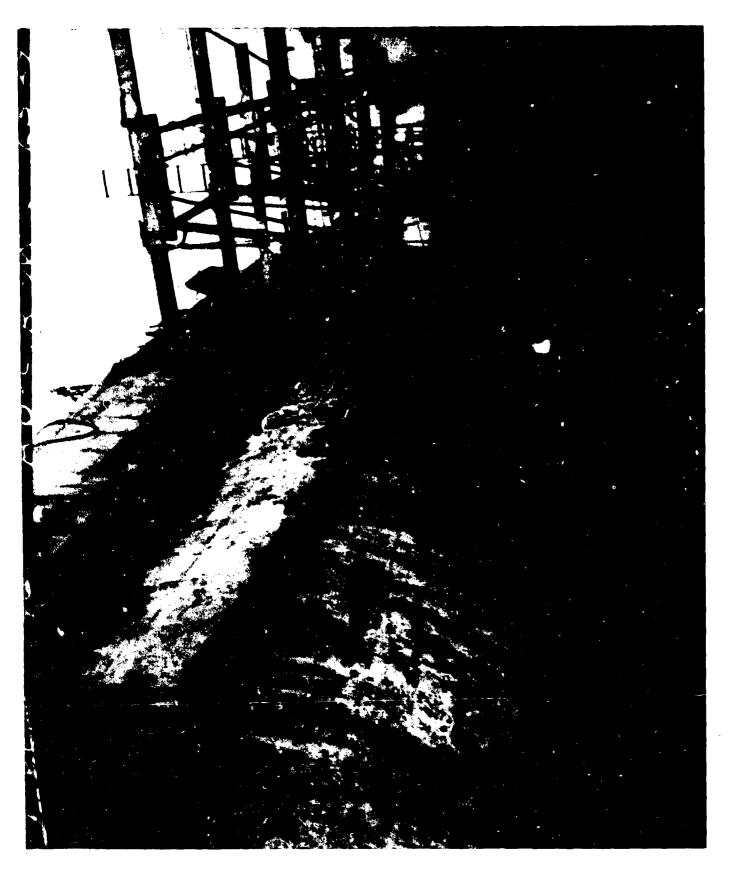
AB-CR-MIK-6529-9. General view of dimples in single hull-starboard side of forward to pedo room.

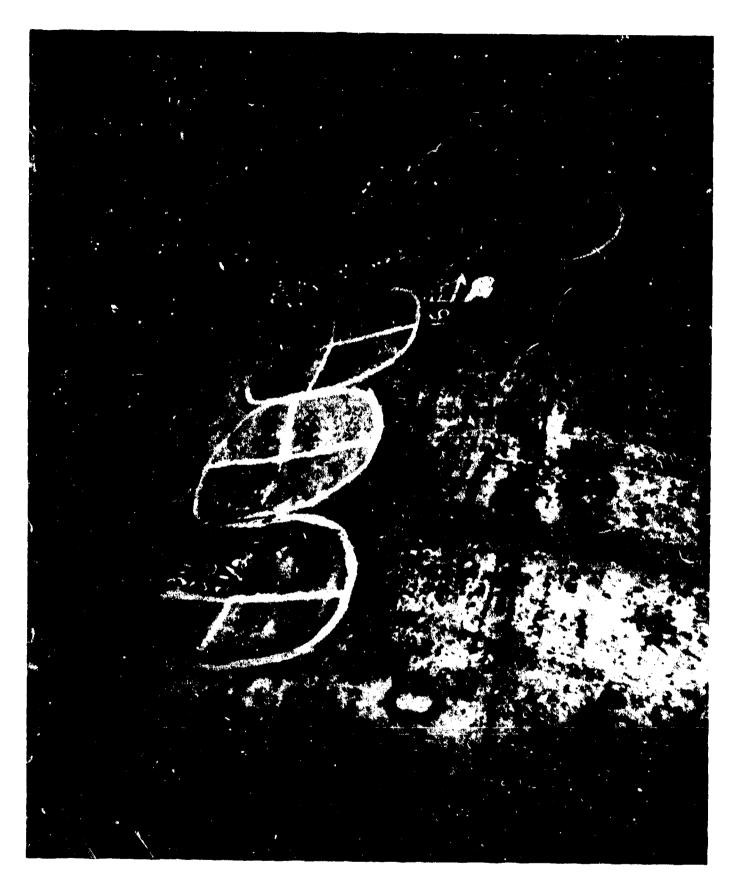
AB-CR-MIG-6523-7. Dimples in non-circular pressure hull - frames 13-17 port.

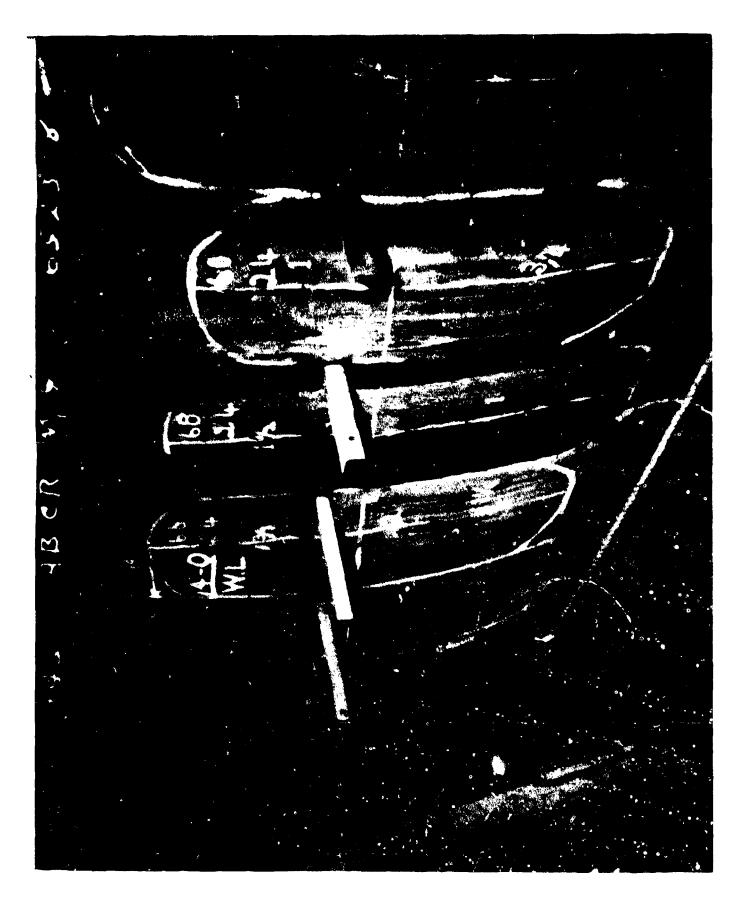
AB-CR-MIG-6523-8. Dimples in non-circular pressure hull - frames 17-21 port.

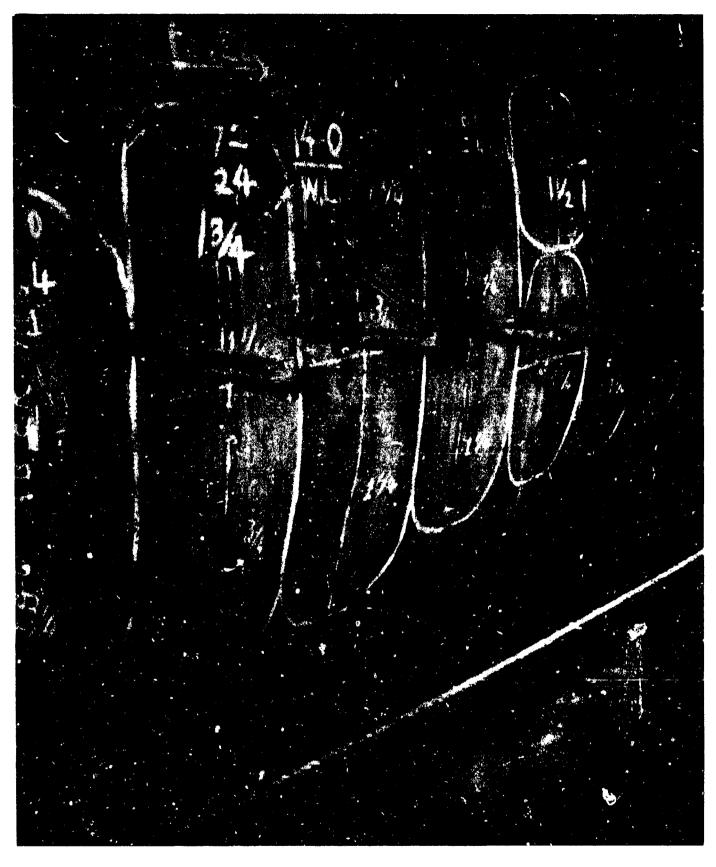
AB-CR-MIG-6523-9. Dimples in non-circular pressure hull - frames 21-25 port.

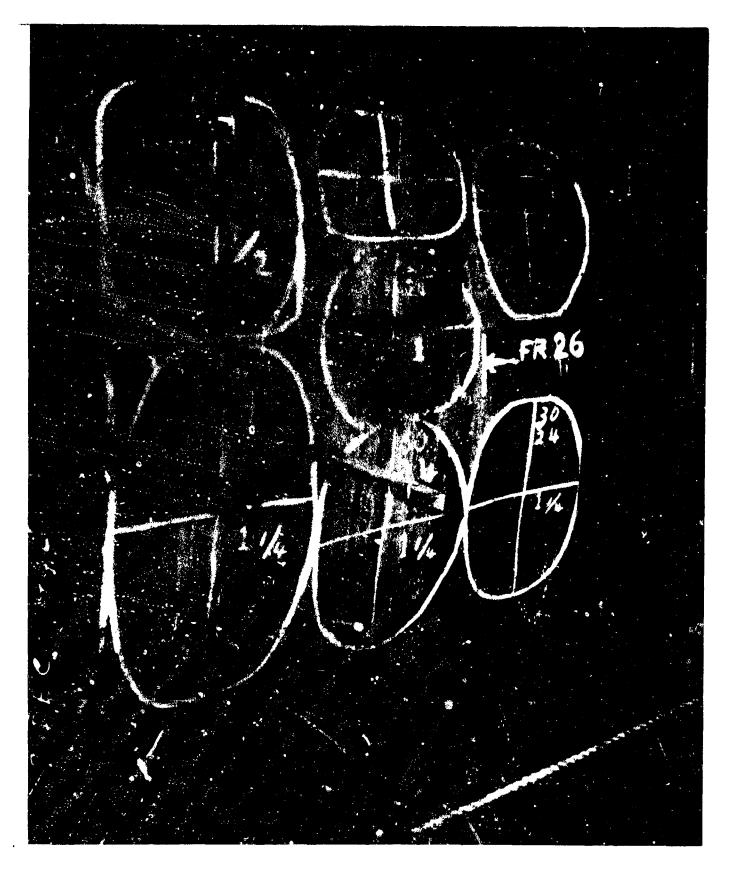
AB-CR-MIG-6523-11. Dimples in non-circular pressure hull - frames 24-27 port.

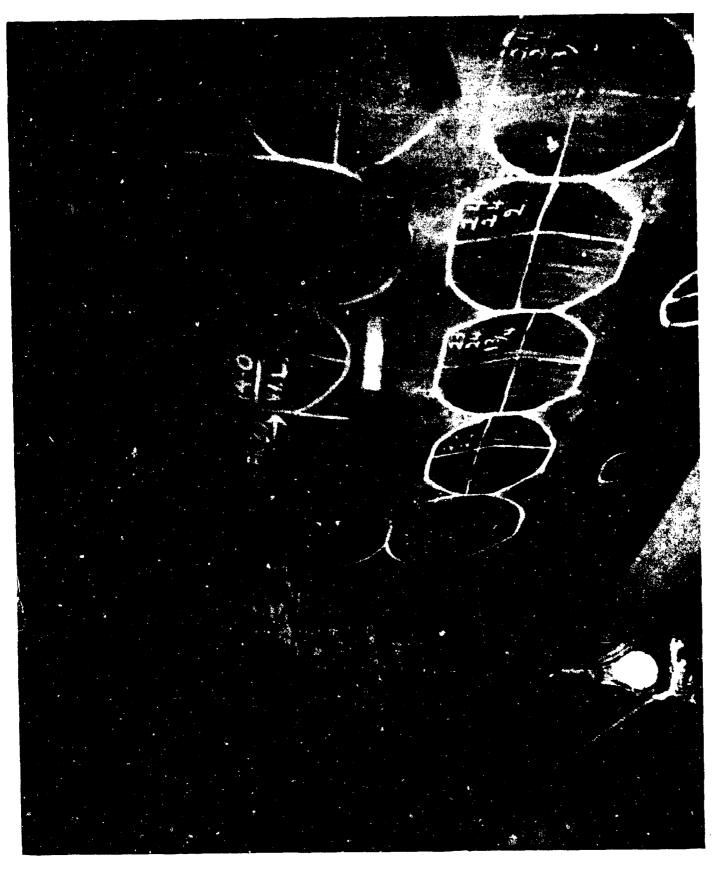
AB-CR-MIG-6523-12. Dimples in non-circular pressure hull - frames 28-33 port.

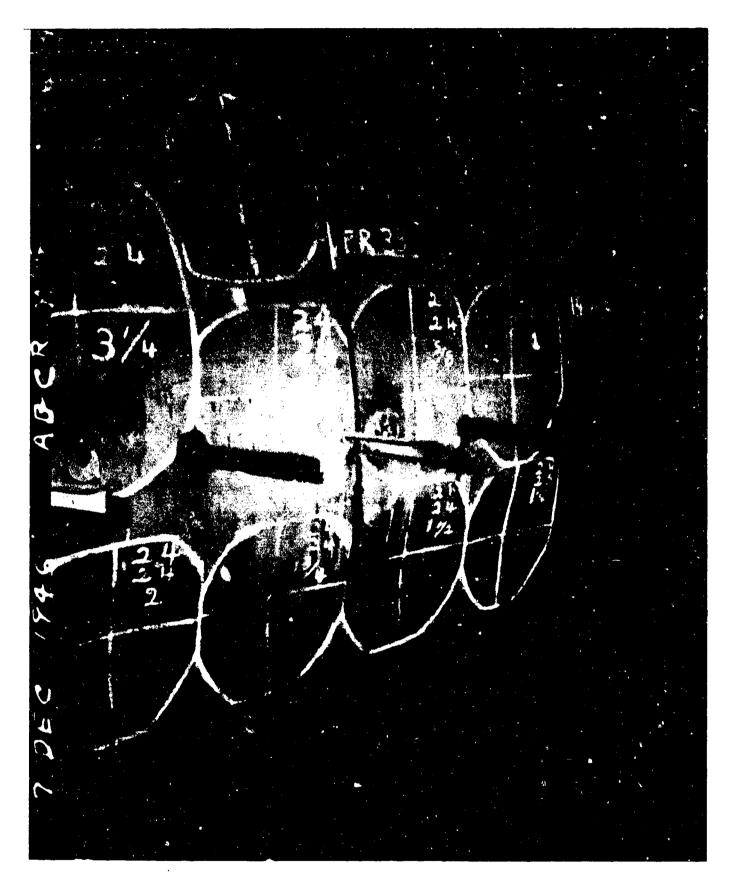
AB-CR-MIG-6526-4. Dimples in non-circular pressure hull-frames 32-35 port.

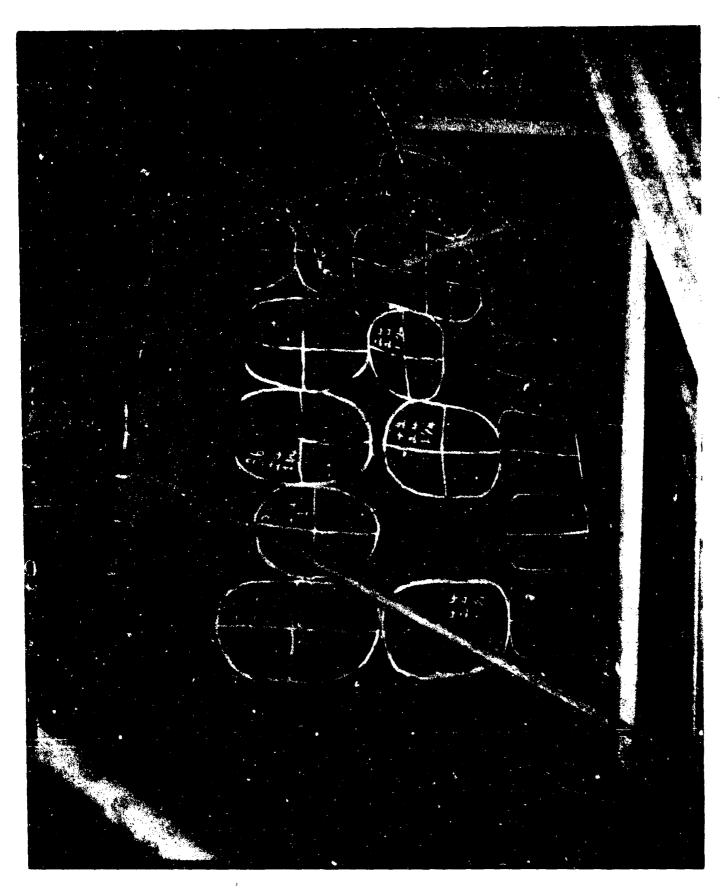
AB-CR-MIG-6527-10. Dimples in non-circular pressure hull - frames 155-162, port, from keel to maximum beam.

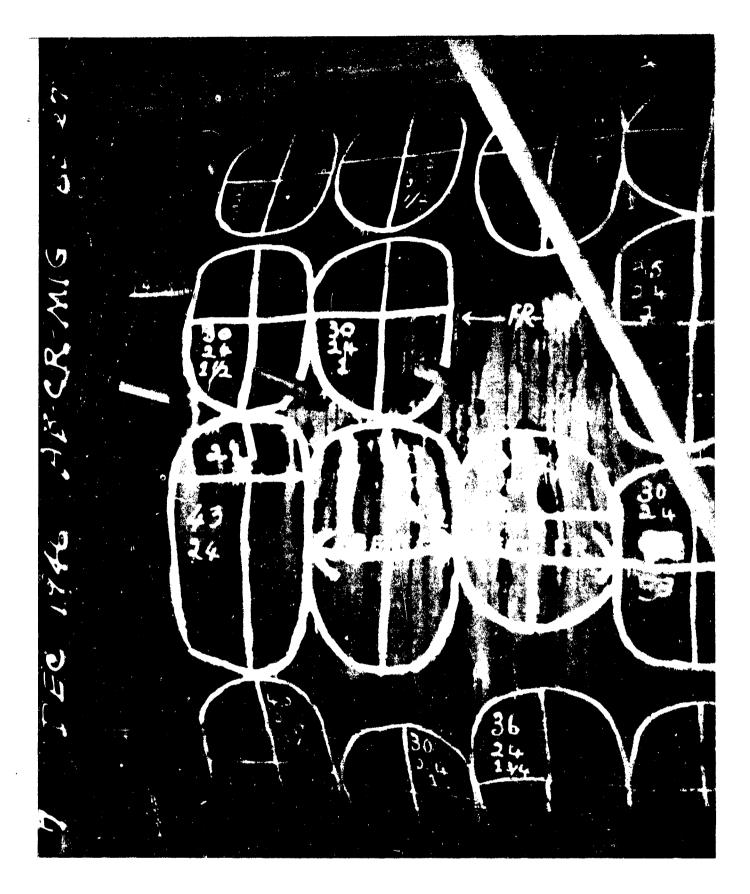
AB-CR-MIG-6527-11. Dimples in non-circular pressure hull - frames 155-159, port from maximum beam to top.

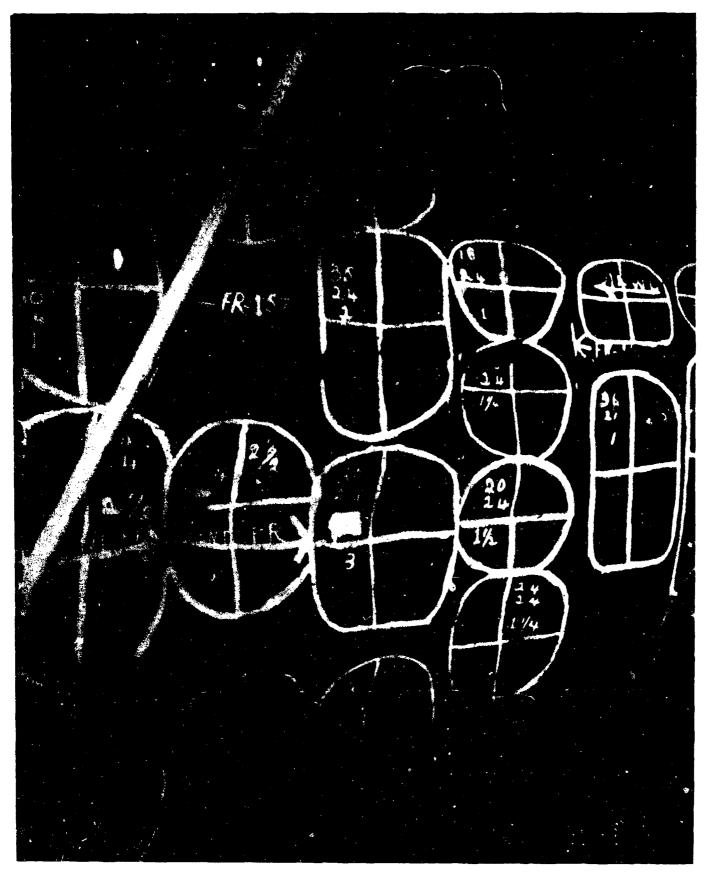
AB-CR-MIG-6527-12. Dimples in non-circular pressure hull - frames 157-161, port.

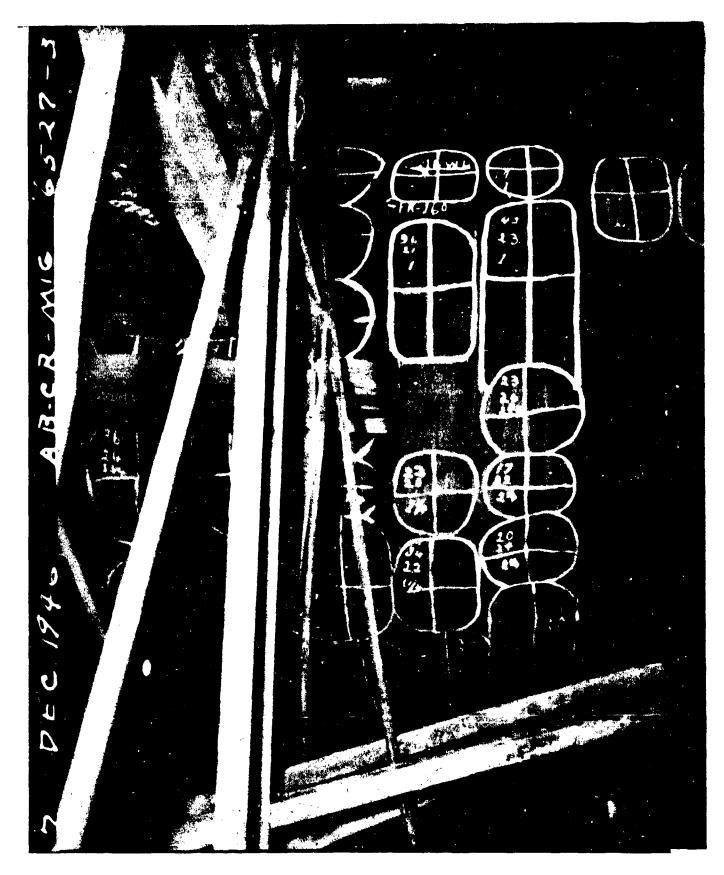
AB-CR-MIG-6527-3. Dimples in non-circular pressure hull - frames 160-164, port.

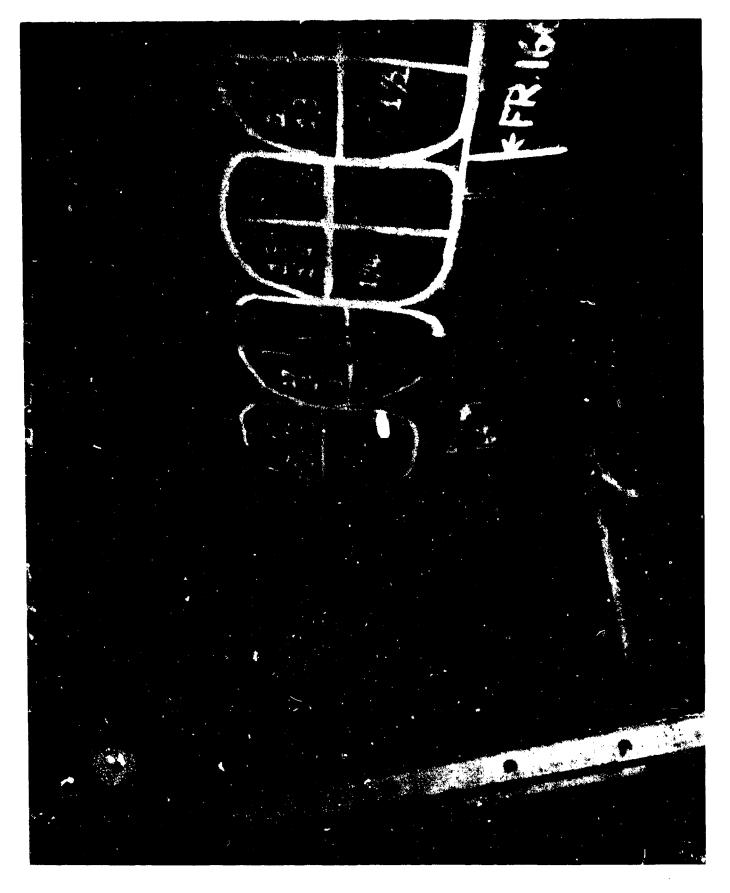
AB-CR-MIG-6526-12. Dimples in non-circular pressure hull - frames 160-166, port.

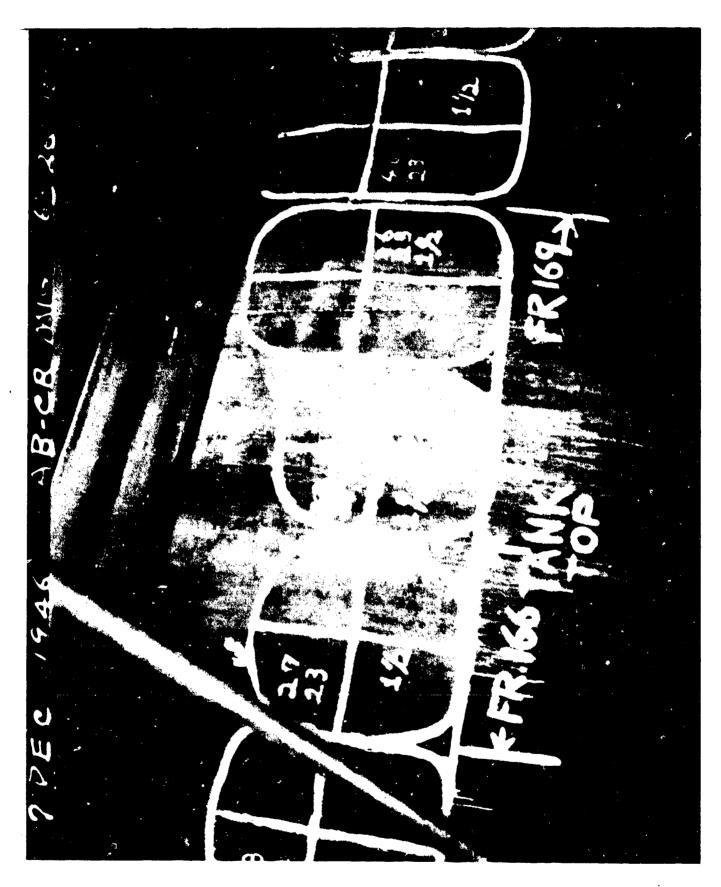
AB-CR-MIG-6526-11. Dimples in non-circular pressure hull - frames 166-170, port.

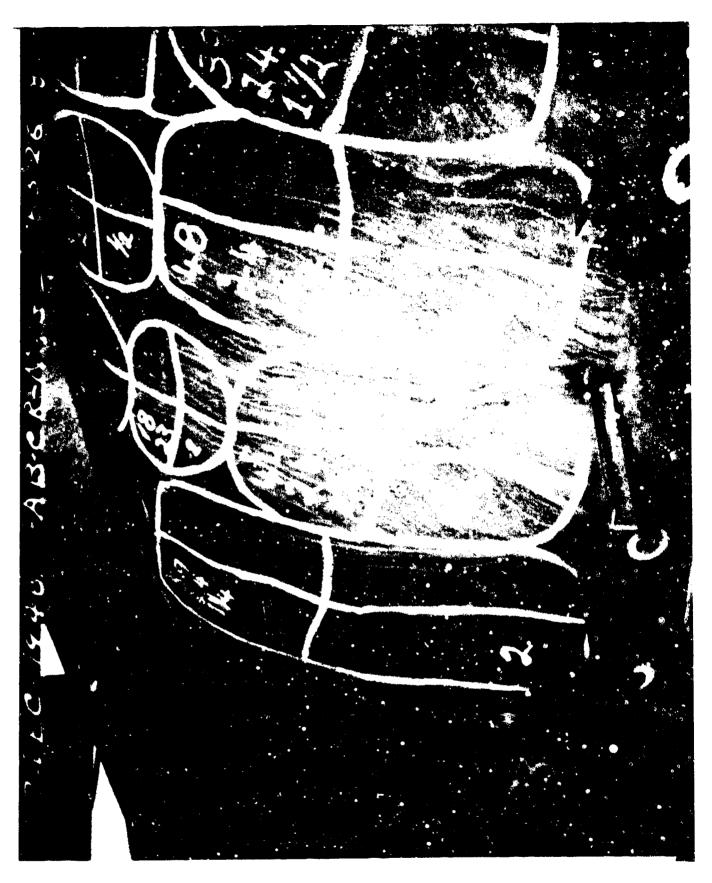
AB-CR-MIG-6526-8. Dimples in non-circular pressure hull - frames 174-177, port.

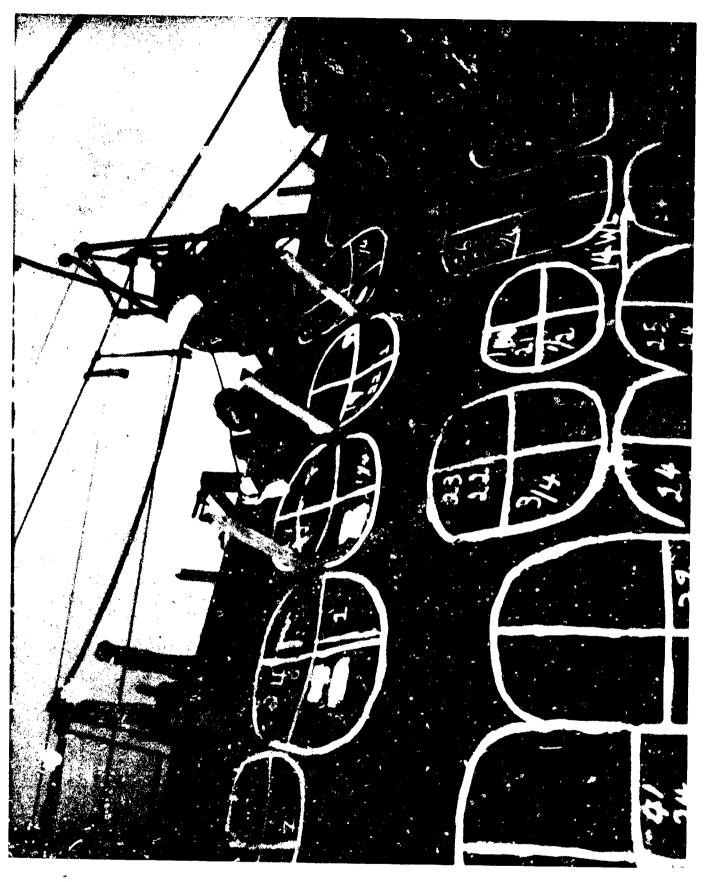
AB-CR-MIG-6527-4. Dimples in non-circular pressure hull - frames 172-178, port, maximum beam to top.

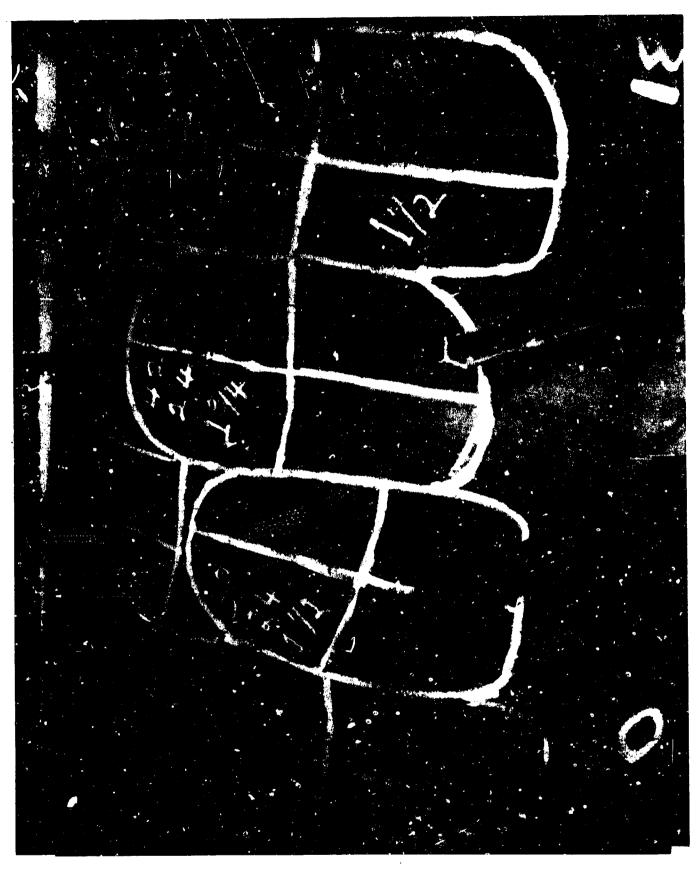
AB-CR-MIG-6526-9. Diraples in non-circular pressure hull - frames 176-180, port, just above keel.

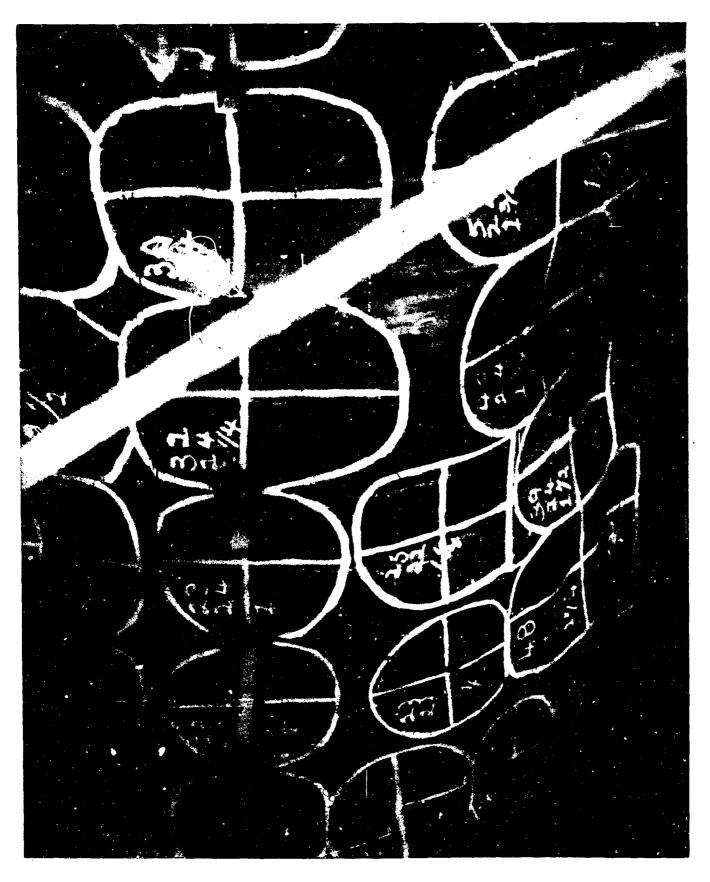
AB-CR-MIG-6527-5. Dimples in non-circular pressure hull - frames 176-180, port just above keel.

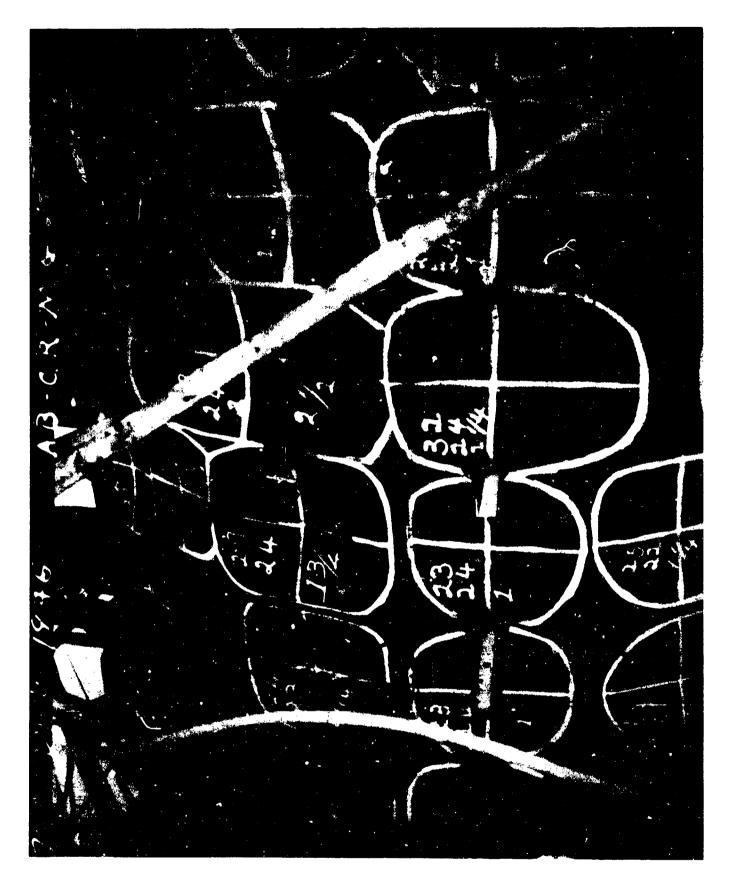
AB-CR-MIG-6527-6. Dimples in non-circular pressure hull - frames 176-180, port maximum beam to top.

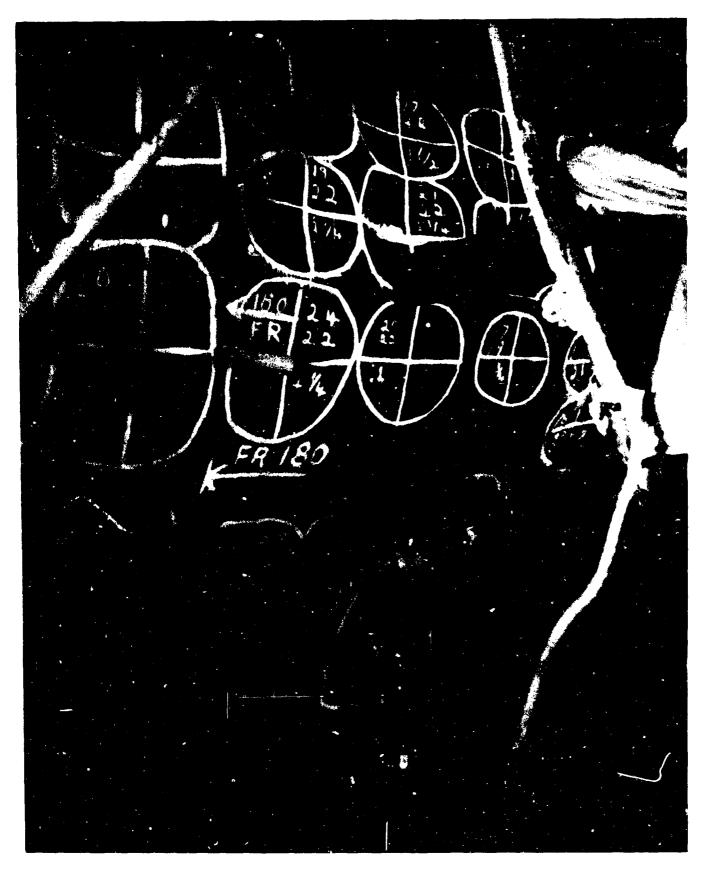
AB-CR-MIG-6527-7. Dimples in non-circular pressure hull - frames 179-184, port.

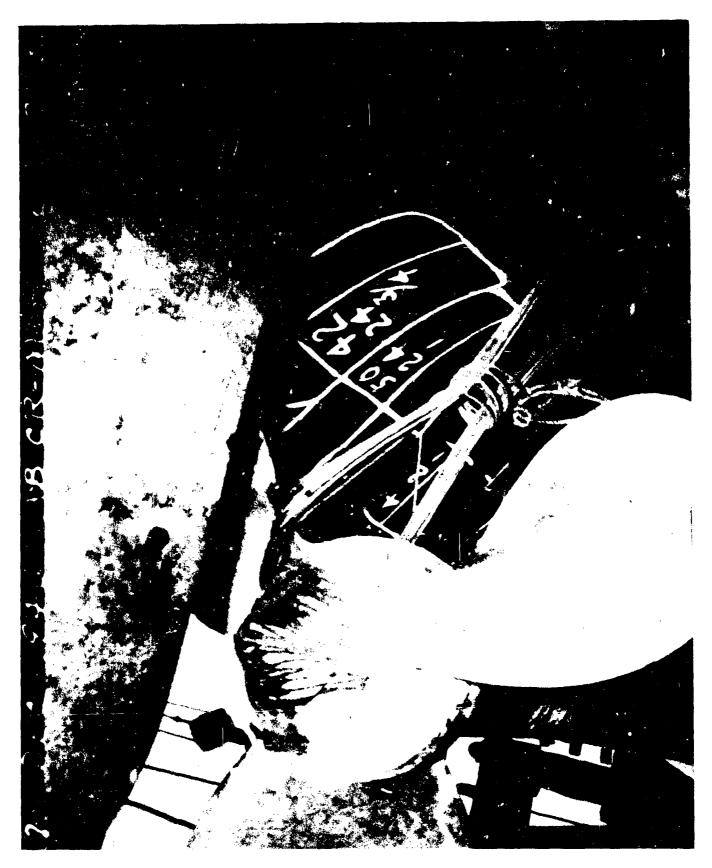
AB-CR-MIG-6527-9. Dimples in non-circular pressure hull - frames 181-183, port.

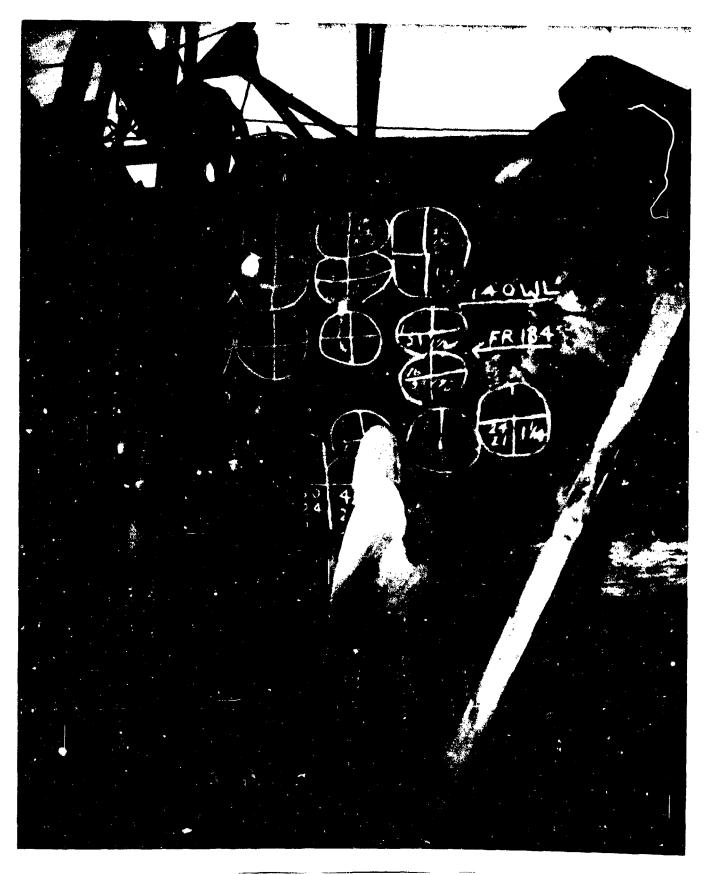
AB-CR-MIG-6527-8. Dimples in non-circular pressure hull - frames 181-185, port.

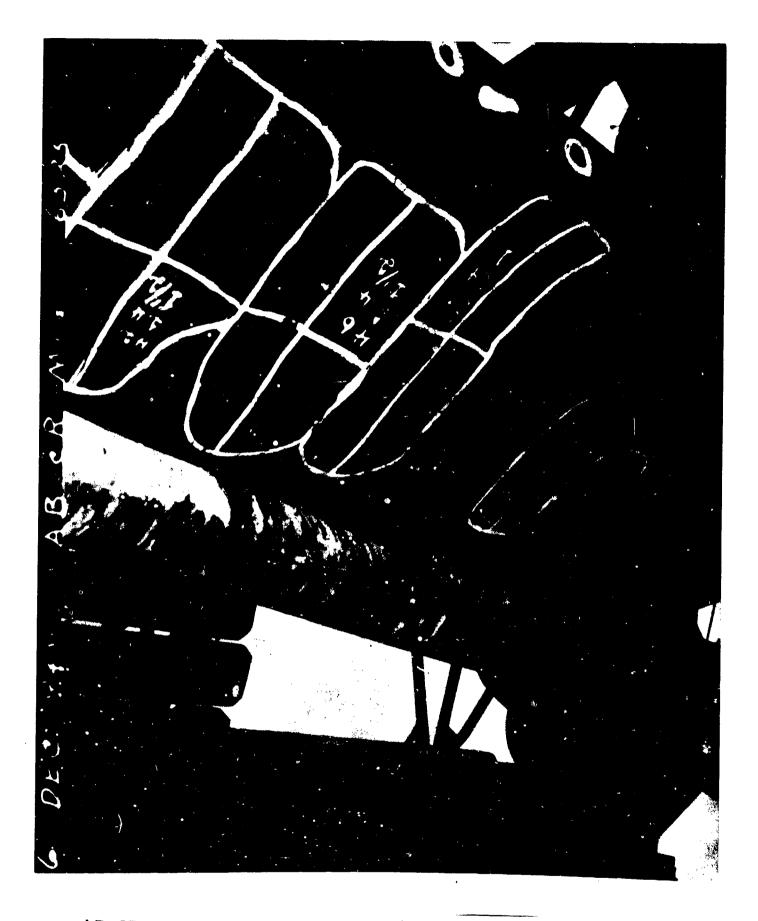
AB-CR-MIG-6525-11. Dimples in non-circular pressure huli - frames 178-184, starboard.
